1. AGENCY USE ONLY (Leave blank)		2. REPORT DATE January 1998	3. REPORT TYPE AND DATES COVERED Final 1 Feb 1995 - 30 Sept 1996	
4. TITLE AND SUBTITLE Surface Treatment of High Performance Marine Alloys to Enhance Crevice Corrosion Resistance in Critical Seawater Applications			5. FUNDING NUMBERS C N000144-95C-001

6. AUTHOR(S) Robert M. Kain				
7. PERFORMING ORGANIZATION NAME(S) AND ADDRESS(ES) LaQue Center for Corrosion Technology, Inc. 702 Causeway Drive, Post Office Box 656 Wrightsville Beach, North Carolina 28480			8. PERFORMING ORGANIZATION REPORT NUMBER

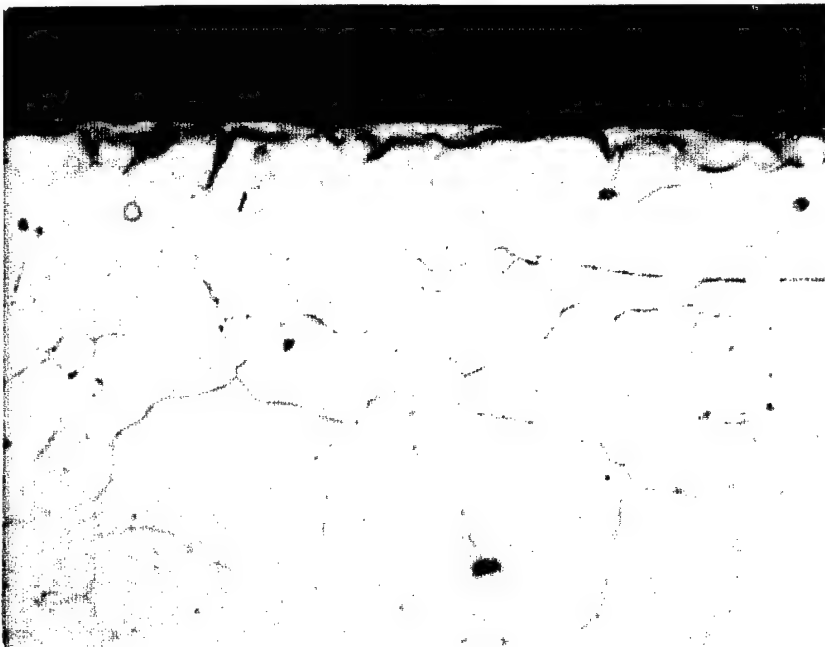
(a) 100X (differential interference contrast) 97459-1

(b) 1000X 97459-3

Figure 1. Etched microstructure of N06625 pipe tested  
(electrolytic chromic-acetic acid etchant)

Samples of the as-produced and electropolished (ID/OD) test pipes were subjected to Scanning Electron Microscope/Energy Dispersive Spectroscopy (SEM/EDS) analyses by the same equipment and profiling technique employed in the previously reported study by Oldfield.<sup>9</sup> Analyses of the OD pipe surfaces were also performed. Results of the profiling analyses for chromium are plotted in Figure 23 as a function of distance inward from the edge of the cross-sectioned material. As can be seen, the analyses show considerable chromium depletion at the OD edge of as-produced pipe, and some enrichment at the OD edge of the electropolished pipe. The degree of depletion shown in Figure 23 is considerably greater than that described earlier by Oldfield<sup>9</sup> for mill pickled sheet material of the same alloy. At a profile depth of about 15 $\mu$ m, and inward, the level of chromium analyzed for both the as-produced and electropolished pipes approximated, within 1%, the actual level shown for the mill heat analysis. The above depth of chromium depletion at the surface of the as-produced pipe appears consistent with the near surface feature shown in the 1000X optical photomicrograph in Figure 1b.

According to literature provided by the electropolisher, this process involves removal of less than 1 mil ( $\sim 25\text{ }\mu\text{m}$ ) of material; more typically about 0.4 mils ( $10\text{ }\mu\text{m}$ ). By reference again to Figure 23 and Figure 1b, it is apparent that this was sufficient to remove the chromium depleted surface layer in the as-produced N06625 pipe tested. Figure 23 may also be useful in explaining the limited penetration ( $\leq 0.01\text{ mm}$ ) which occurred at all the affected sites on the as-produced pipe specimens exposed to cold natural seawater and to chlorinated seawater. Conceivably, as the initial attack following breakdown of passivity deepened it was confronted by the increasingly more corrosion resistant composition. As illustrated previously by Figure 23, this more resistant composition begins, in this material, at a profile depth of about  $4\text{ }\mu\text{m}$  ( $0.004$  or  $<0.01\text{ mm}$ ). The occurrence of substantial deeper attack at several affected sites in the warm seawater tests is not consistent with the above discussion regarding gradations in material resistance from the surface inwards. Because chromium is considered to be a major contributor to the fall in pH within the crevice,<sup>10</sup> exposure to the higher chromium containing material below the now-removed depleted layer may have contributed to the development of a more acidic crevice environment, and hence greater propagation. However, the existence of high levels of chromium at the surface of the resistant electropolished specimens was shown to provide greater resistance to the anolyte investigated. It is

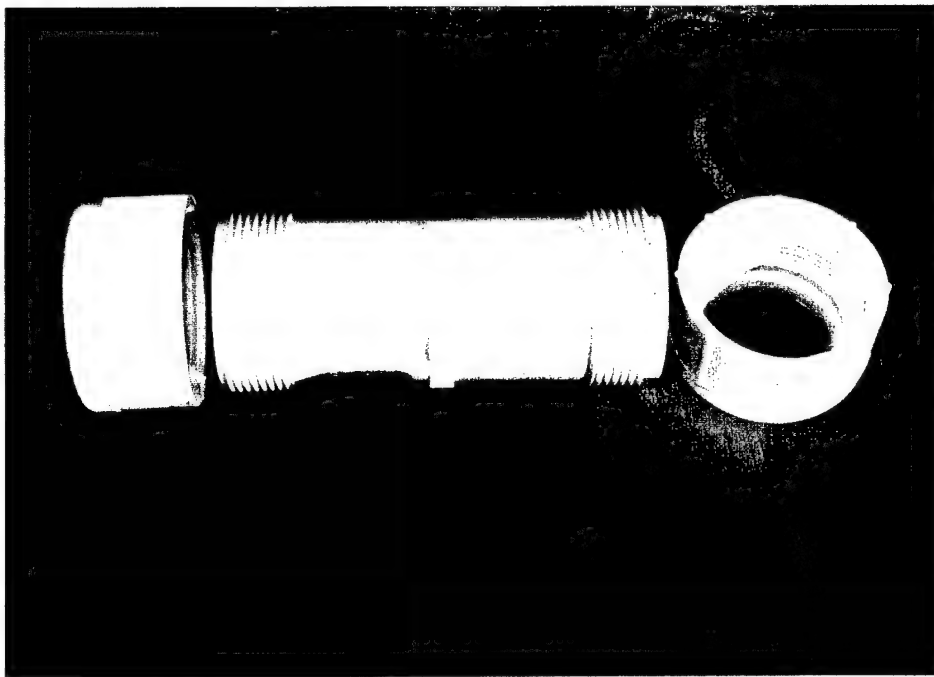
97484-8

Figure 3. "Exploded" view of a compression fitting assembly.

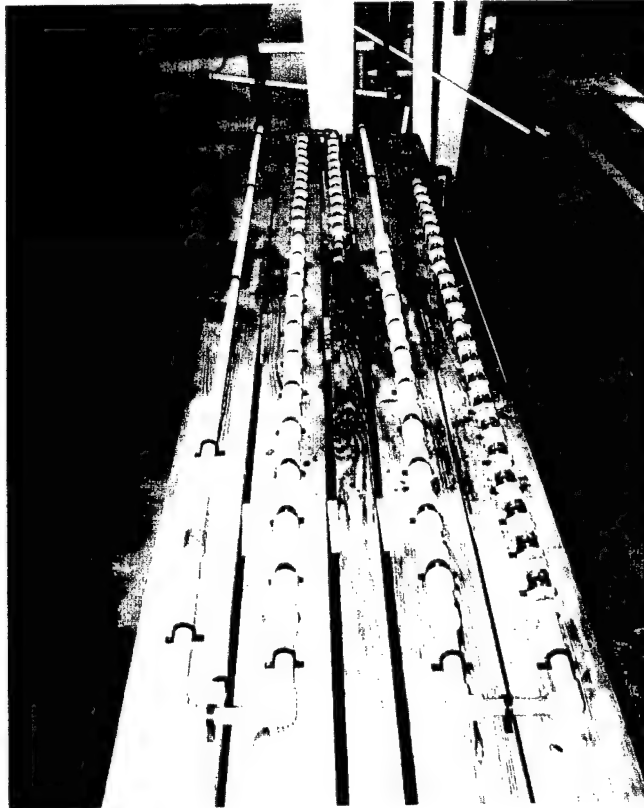
95150-21A

Figure 5. Overall view of completed test assembly comprising pipe specimens with vinyl sleeves (right and rear) and PVC compression fittings with rubber glands (center foreground).

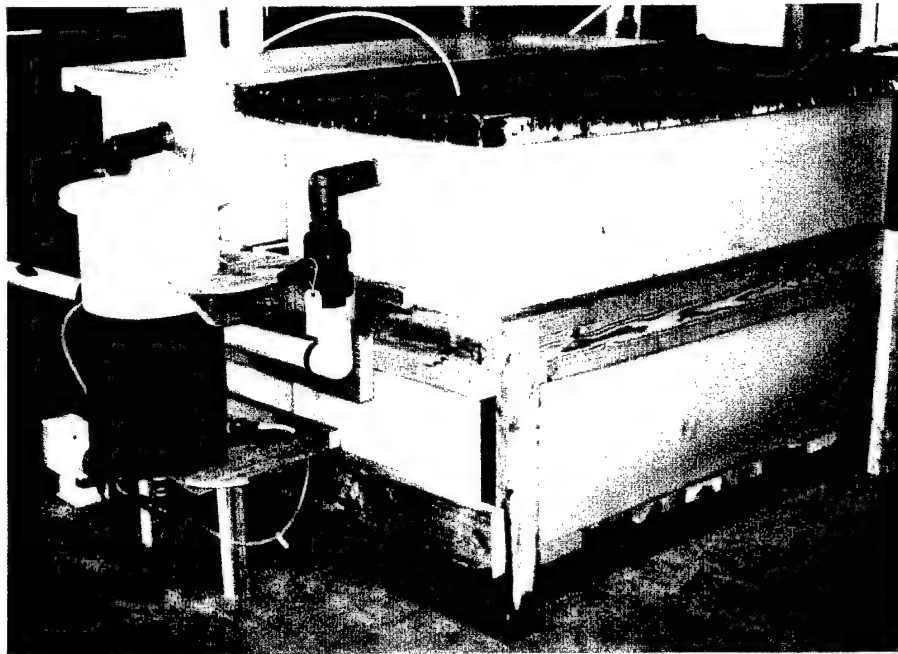
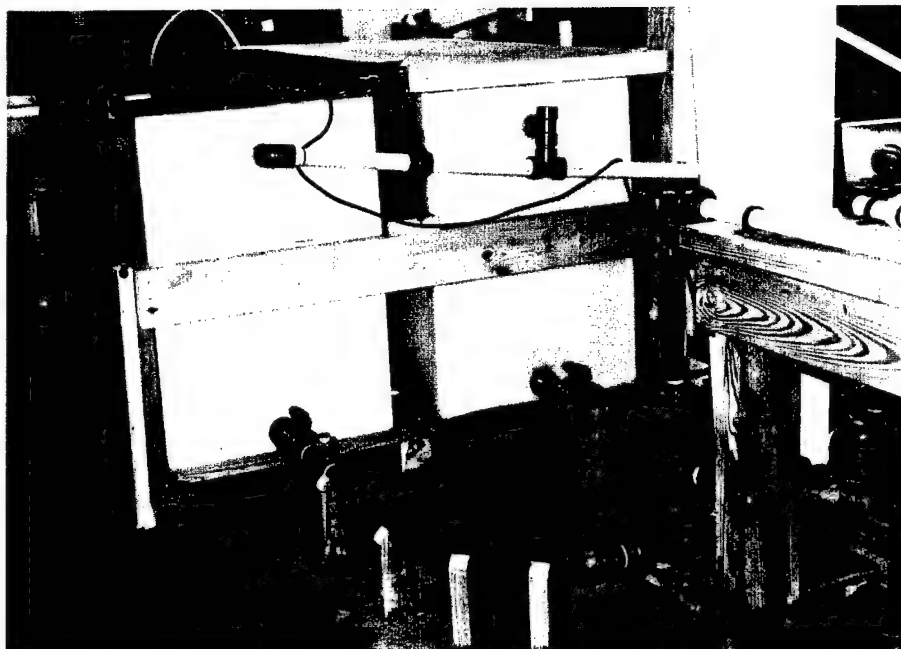
Figure 6. Head tanks used to supply once-through natural and chlorinated seawater to crevice corrosion test assemblies. Hypochlorite reservoir and metering pump shown in top photograph.

Photographs in Figure 6 provide overall views of the supporting apparatus. For those tests requiring chlorination, an auxiliary tank to hold liquid sodium hypochlorite (bleach) and a metering pump was placed in line for direct feed into one of the two seawater tanks.

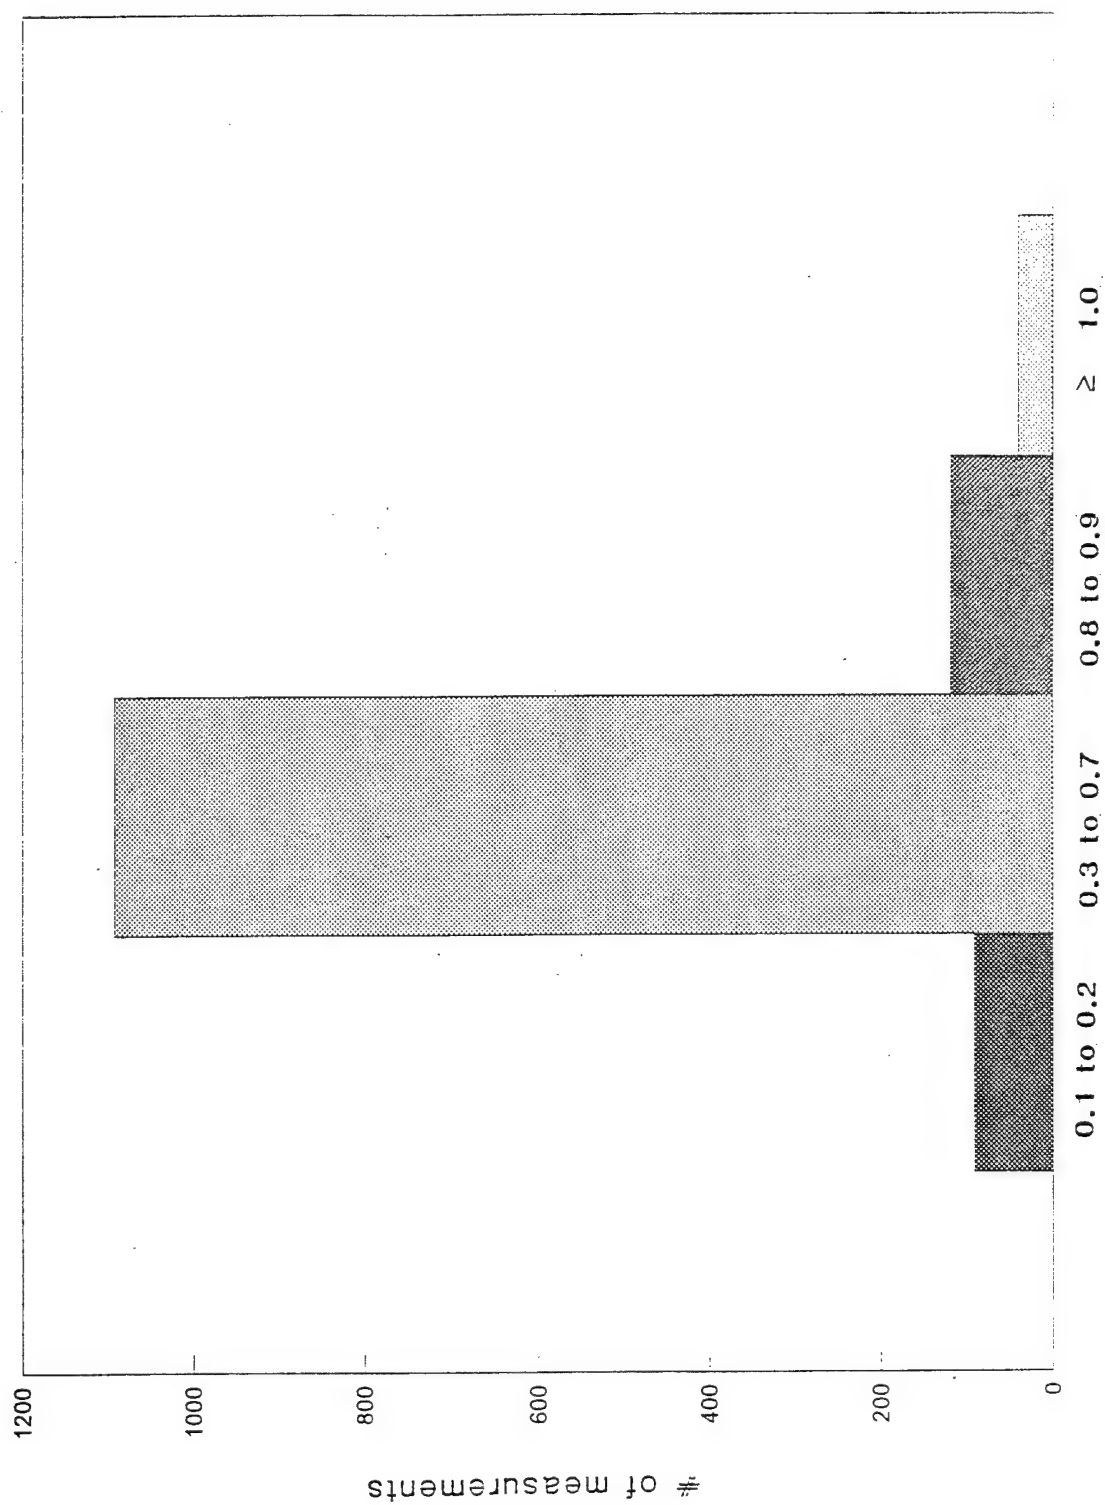
Figure 7. Distribution plot of FAC analyses during 180 day chlorinated seawater test.

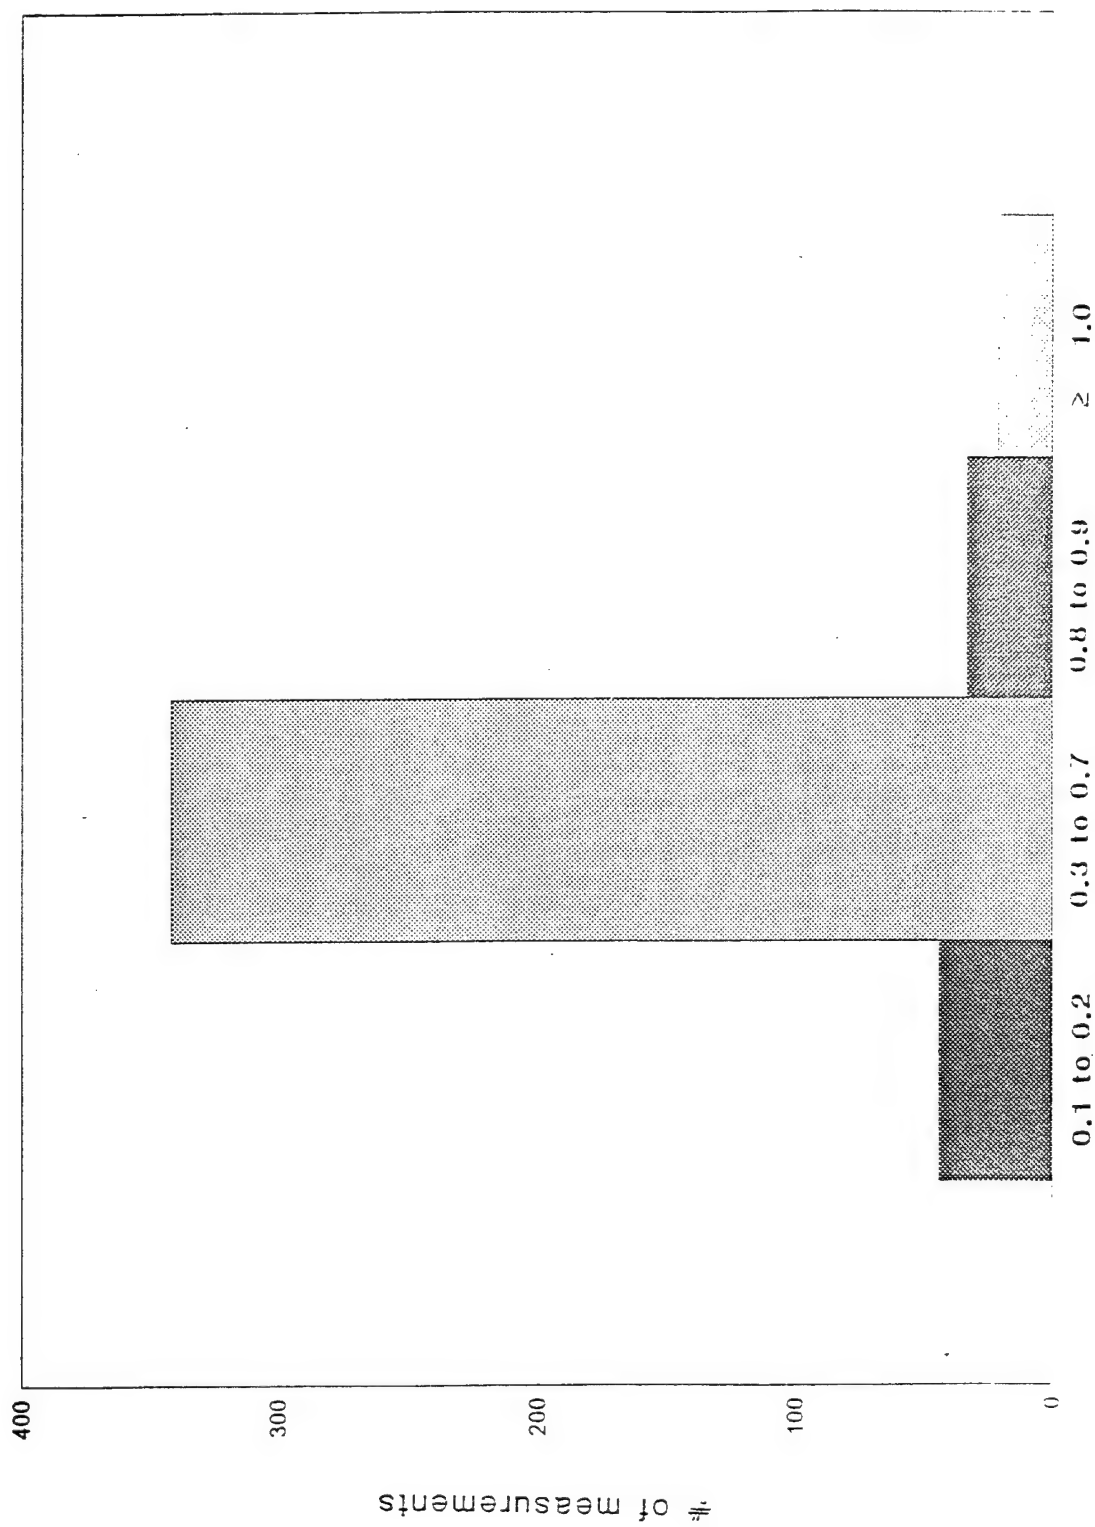
Figure 8. Distribution plot of FAC analyses during 60 day chlorinated seawater test.

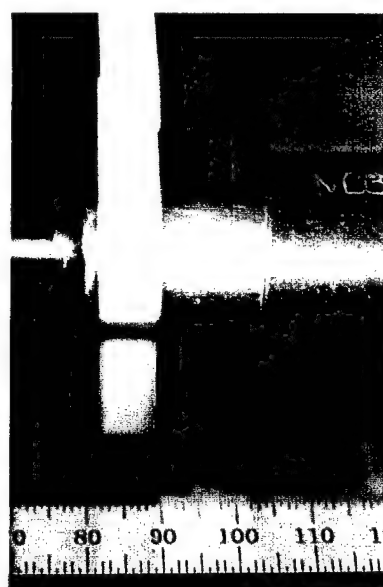
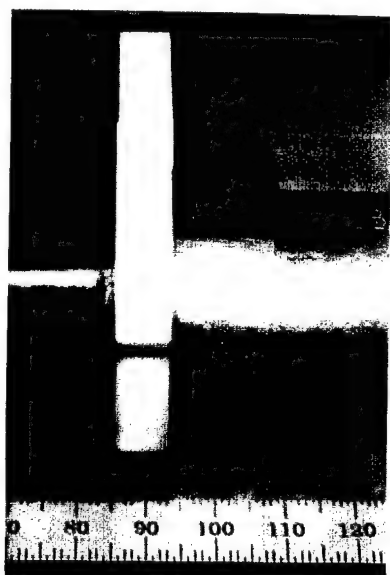
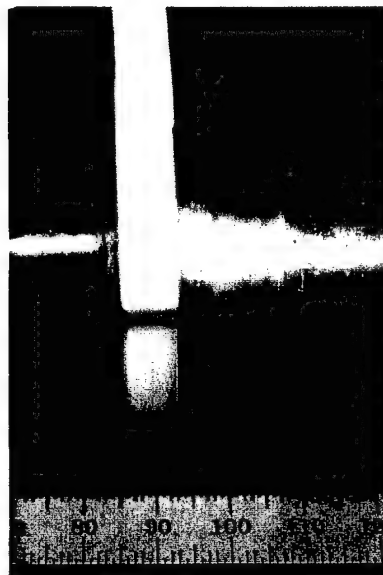
Figure 9. Progression of crevice corrosion for as-produced pipe specimen (No. 002) during 180-day exposure to chlorinated seawater with vinyl sleeve crevice formers.

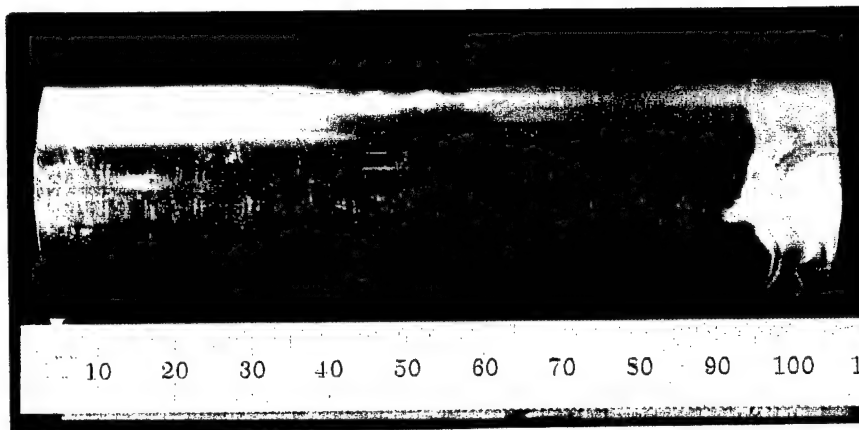
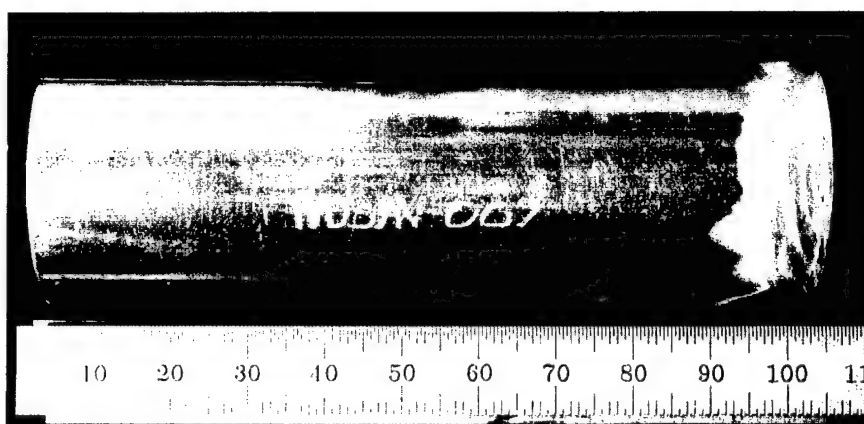
Figure 10. After cleaning views showing examples of crevice corrosion incurred by as-produced pipe specimens in 60-day tests with vinyl sleeve crevice formers:

- a) No. 006 - warm chlorinated seawater
- b) No. 007 - warm natural seawater

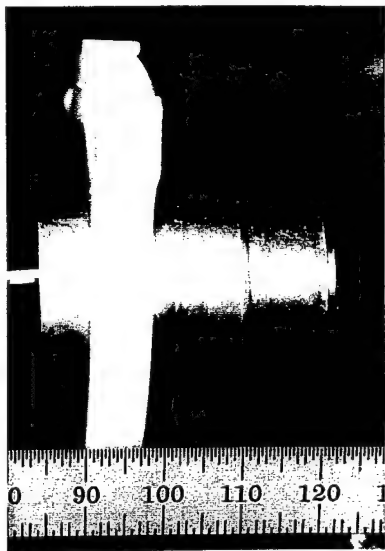
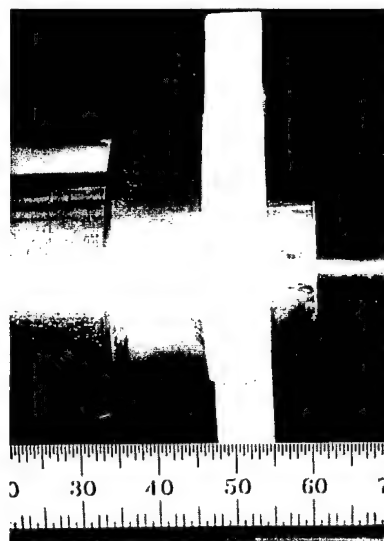
Figure 11. In-situ views showing crevice corrosion incurred by two as-produced pipe specimens, l) No. 017 and r) No. 018, during a 180-day exposure to cold, natural seawater with vinyl sleeve crevice formers.

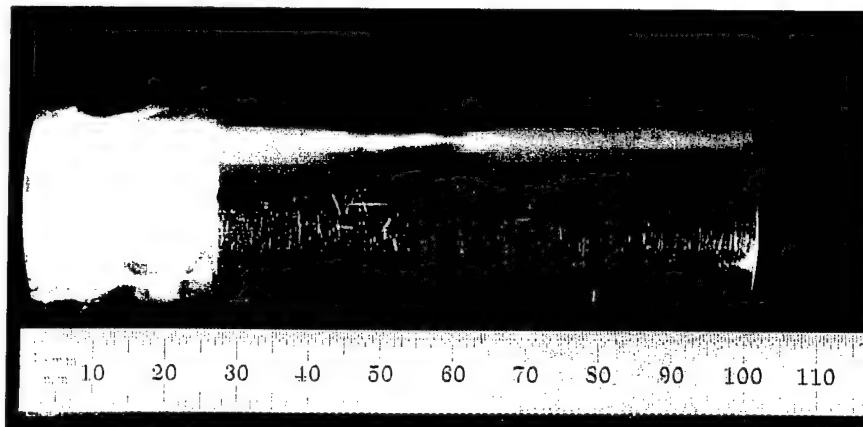
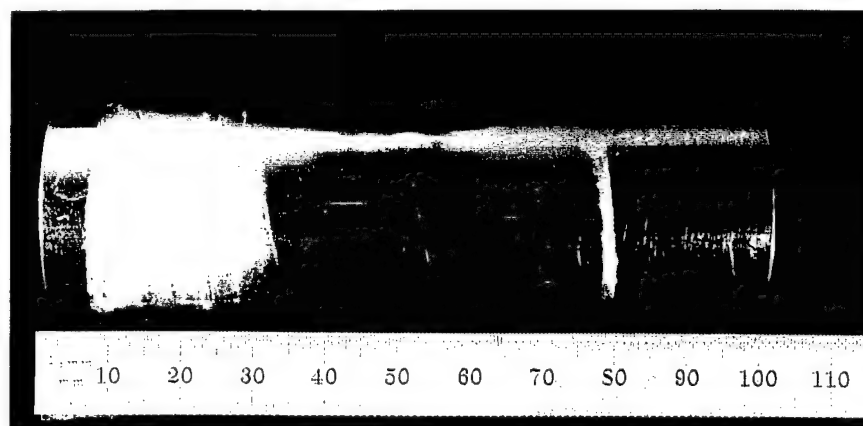
Figure 12. After cleaning views of as-produced pipe specimens showing extent of crevice corrosion incurred during 180-day cold natural seawater test:

- a) No. 018 - vinyl sleeve
- b) No. 019 - rubber gland compression fitting

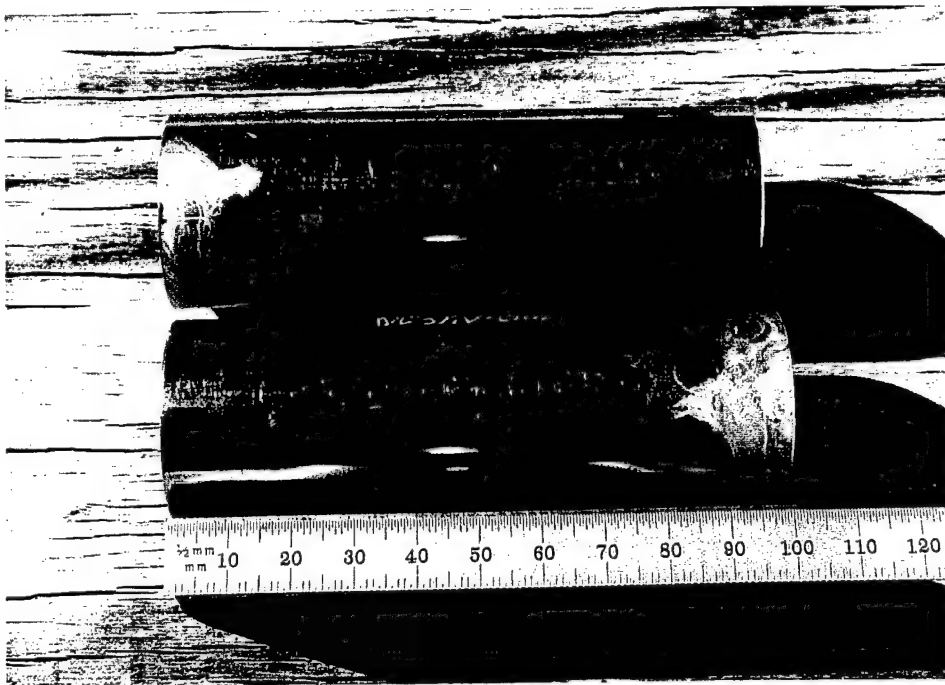
95285-1

Figure 13. After-cleaning view of as-produced pipe specimens, No. 001 and No. 002, following 180-day exposure to chlorinated seawater with vinyl sleeve crevice formers.

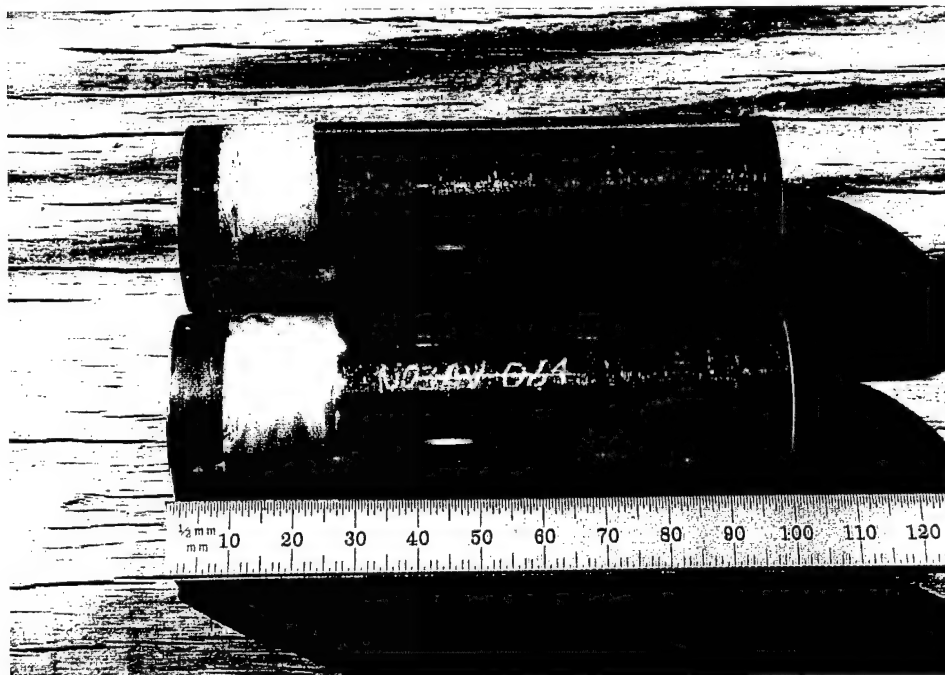
95285-23

Figure 14. After-cleaning view of Cerium (A) treated pipe specimens, No. 063 and No. 064, following 180-day exposure to chlorinated seawater with rubber gland type compression fittings.

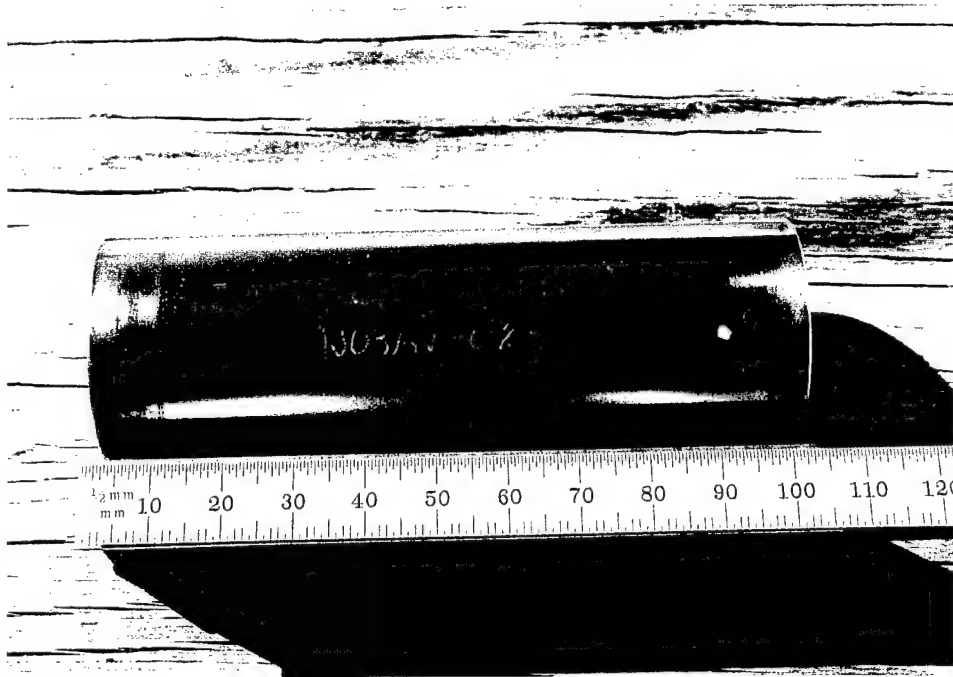
95286-7A

Figure 15. Post test view of electropolished pipe specimen No. 024, after 180-day exposure to chlorinated seawater with rubber gland type compression fitting.

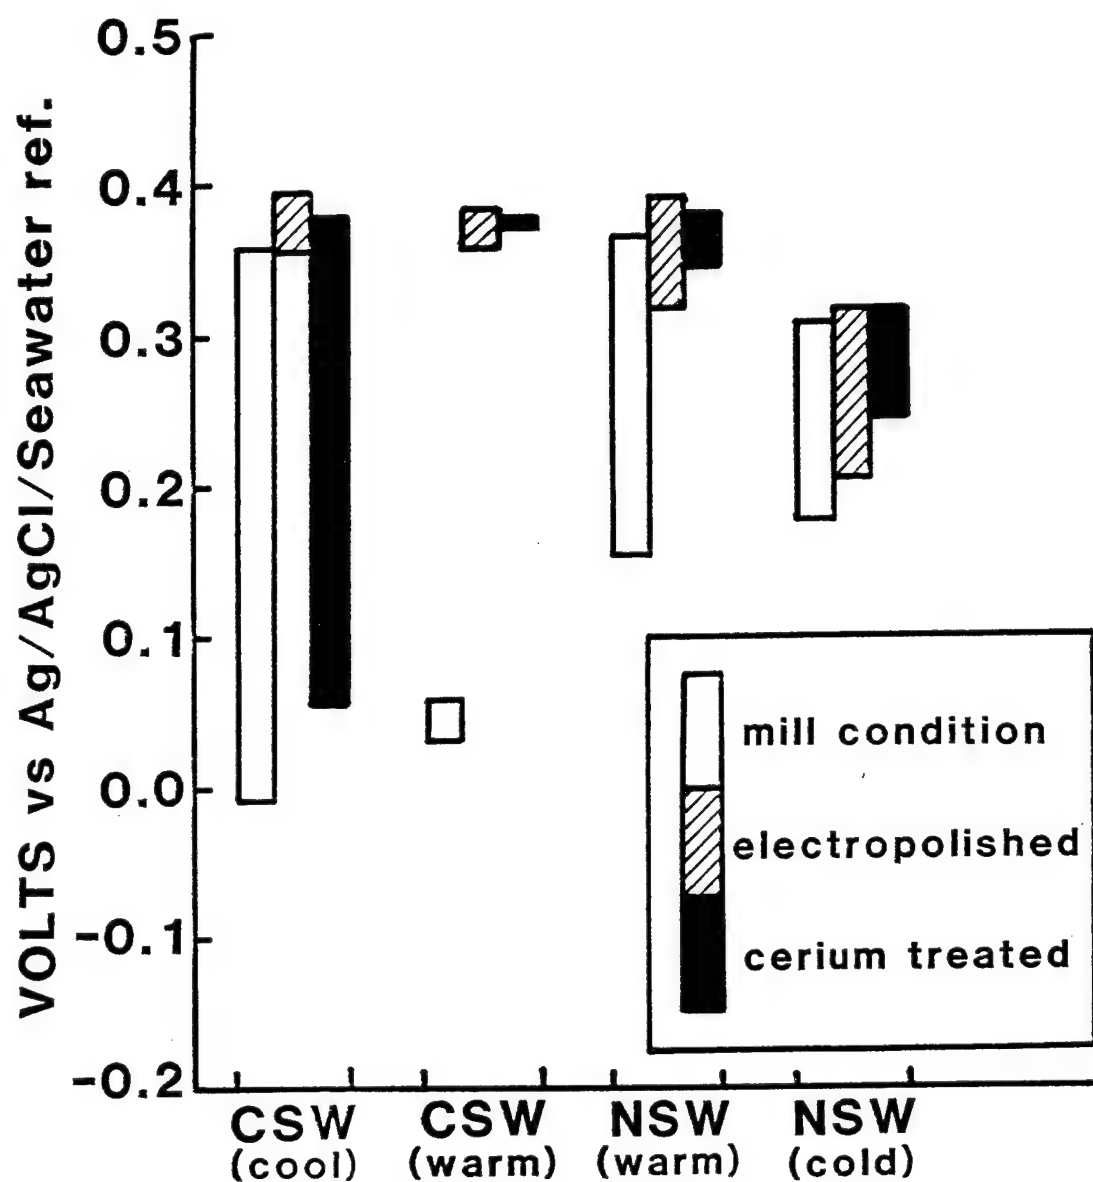
Figure 16. Range of corrosion potentials for various specimen groups after 1000 hours exposure in chlorinated (CSW) and natural (NSW) seawater tests commencing at different times of the year (left - Spring, center - Summer, and right - Winter).

The bar graph in Figure 16 shows the range of corrosion potentials measured for specimens representing the three groups of materials after 1,000 hours in the four indicated tests. These data include potentials for vinyl sleeve and compression fitting assembled specimens having scheduled removals after 60 and/or 180 days. In this analysis, data for the cerium treated (A and B) and the electropolished (OD and OD/ID) specimens have been consolidated, respectively. The potentials shown in Figure 16 (and later in Tables 12 and 13) are mixed potentials indicative of anodic and cathodic reactions taking place on the boldly exposed pipe ID surfaces, as well as those within the crevice on the pipe OD. Results show respectively narrower ranges of potentials for the electropolished and cerium treated specimens, as compared with the as-produced material. Generally, the least variation among materials is noted for the tests commencing in cold natural seawater. As-produced and cerium treated specimens exhibited their greatest variability in the chlorinated seawater test which commenced in early spring. The greatest variation in potential among elec-

The reverse scan low current region shown in Figure 22 for the electropolished material approximates that of the corrosion potentials for electropolished N06625 pipe in the natural and chlorinated seawater as describes in Figure 16 and Tables 12 and 13. Thus, under freely corroding conditions, crevices capable of generating an anolyte pH of 0.2, and perhaps lower, would remain resistant, or corrode at an exceedingly low rate.

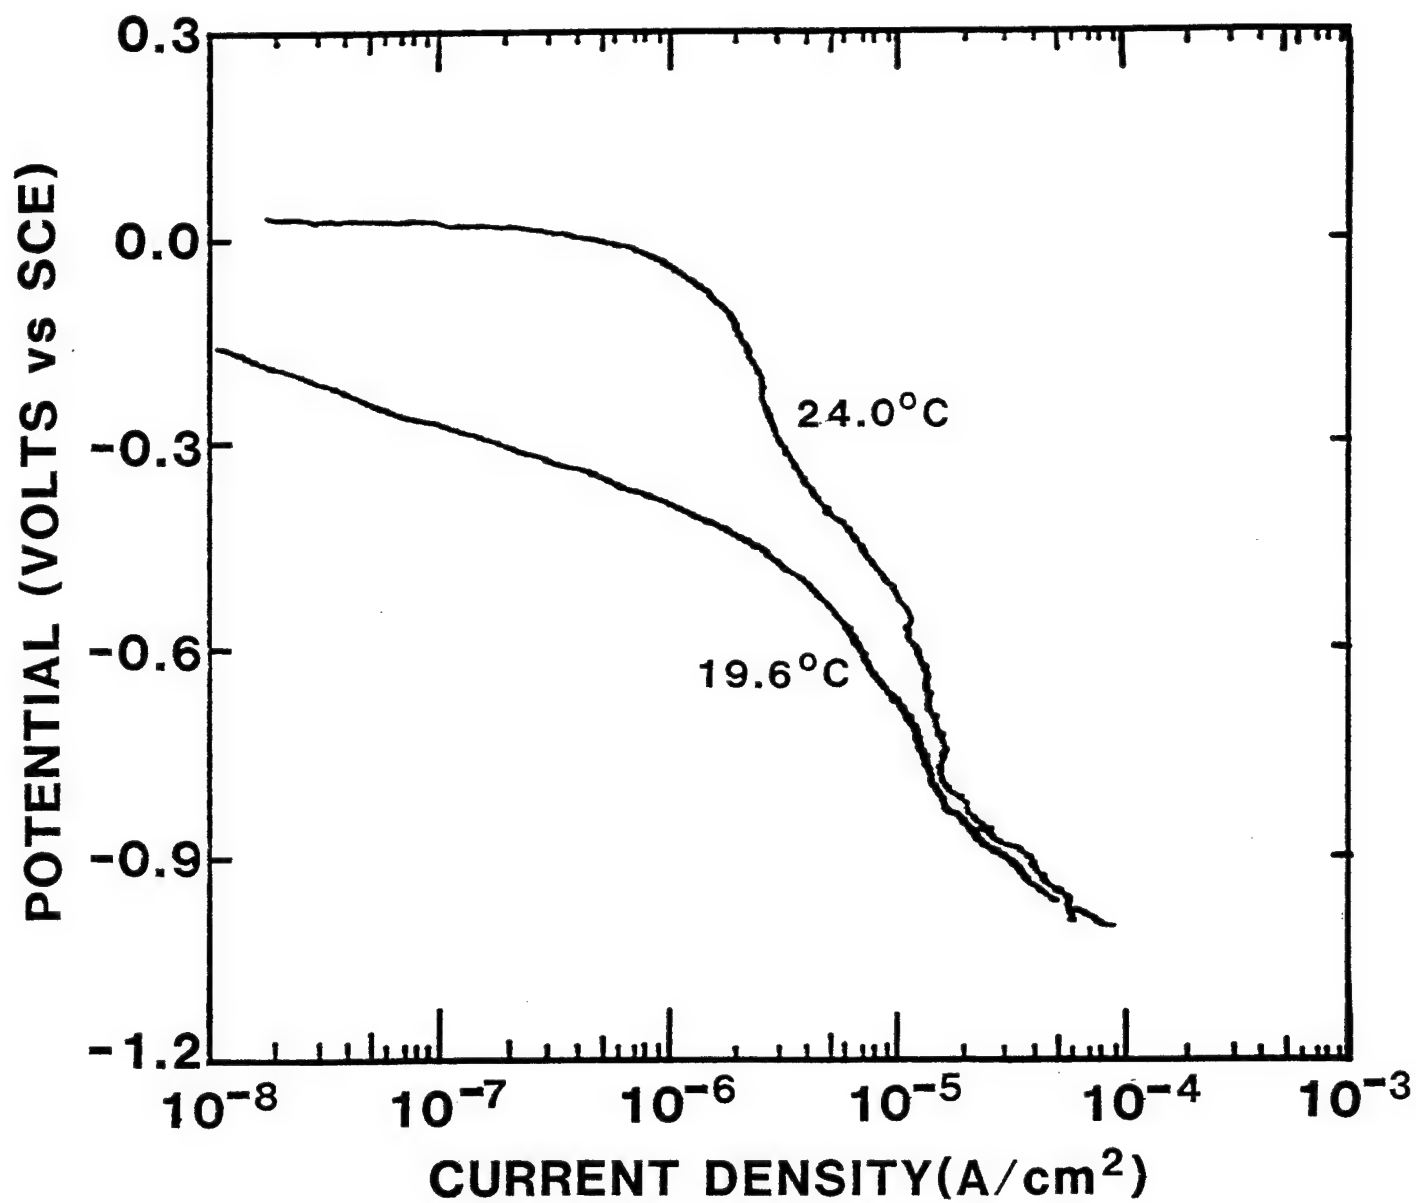
Figure 17. Cathodic polarization behavior for as-produced N06625 pipe pre-exposed to ambient temperature seawater for 12 days.

Prior to cathodic polarization at a scan rate of 0.17 mV/min., electrodes were pre-exposed to nominally quiescent seawater for approximately 12 days to allow for some bio-film formation to occur. One set of electrodes was pre-exposed at a time when the average daily seawater temperatures over 12 days was 19.6°C and another set at 24.0°C. Figures 17 to 19 show the cathodic polarization curves for electrodes prepared from as-produced, electropolished and cerium treated (A) pipes tested after the two pre-exposure periods. As can be seen, exposure to the warmer seawater with its presumably increased level of bio-activity resulted in increased cathodic current associated with enhanced oxygen reduction and/or some other reaction.<sup>16</sup> Previously, Shaw et al.,<sup>11</sup> reported a similar trend as a function of exposure period which was accompanied with changes in seawater temperatures. Figure 20 compares cathodic polarization curves for the various test materials after pre-exposure to the warmer seawater environment. Note that the curve for the electropolished material is shifted toward a lower potential-current density regime relative to that for the as produced and cerium treated materials. It is presently uncertain if the observed differences in polarization behavior after pre-exposure to seawater is due to differences in bio-film formation or to the presence of an enhanced passive oxide layer on the electropolished material, or to some combination of the two. The observed shift for electropolished alloy N06625 is not as great as that reported previously in similar type tests for S31600.<sup>12</sup>

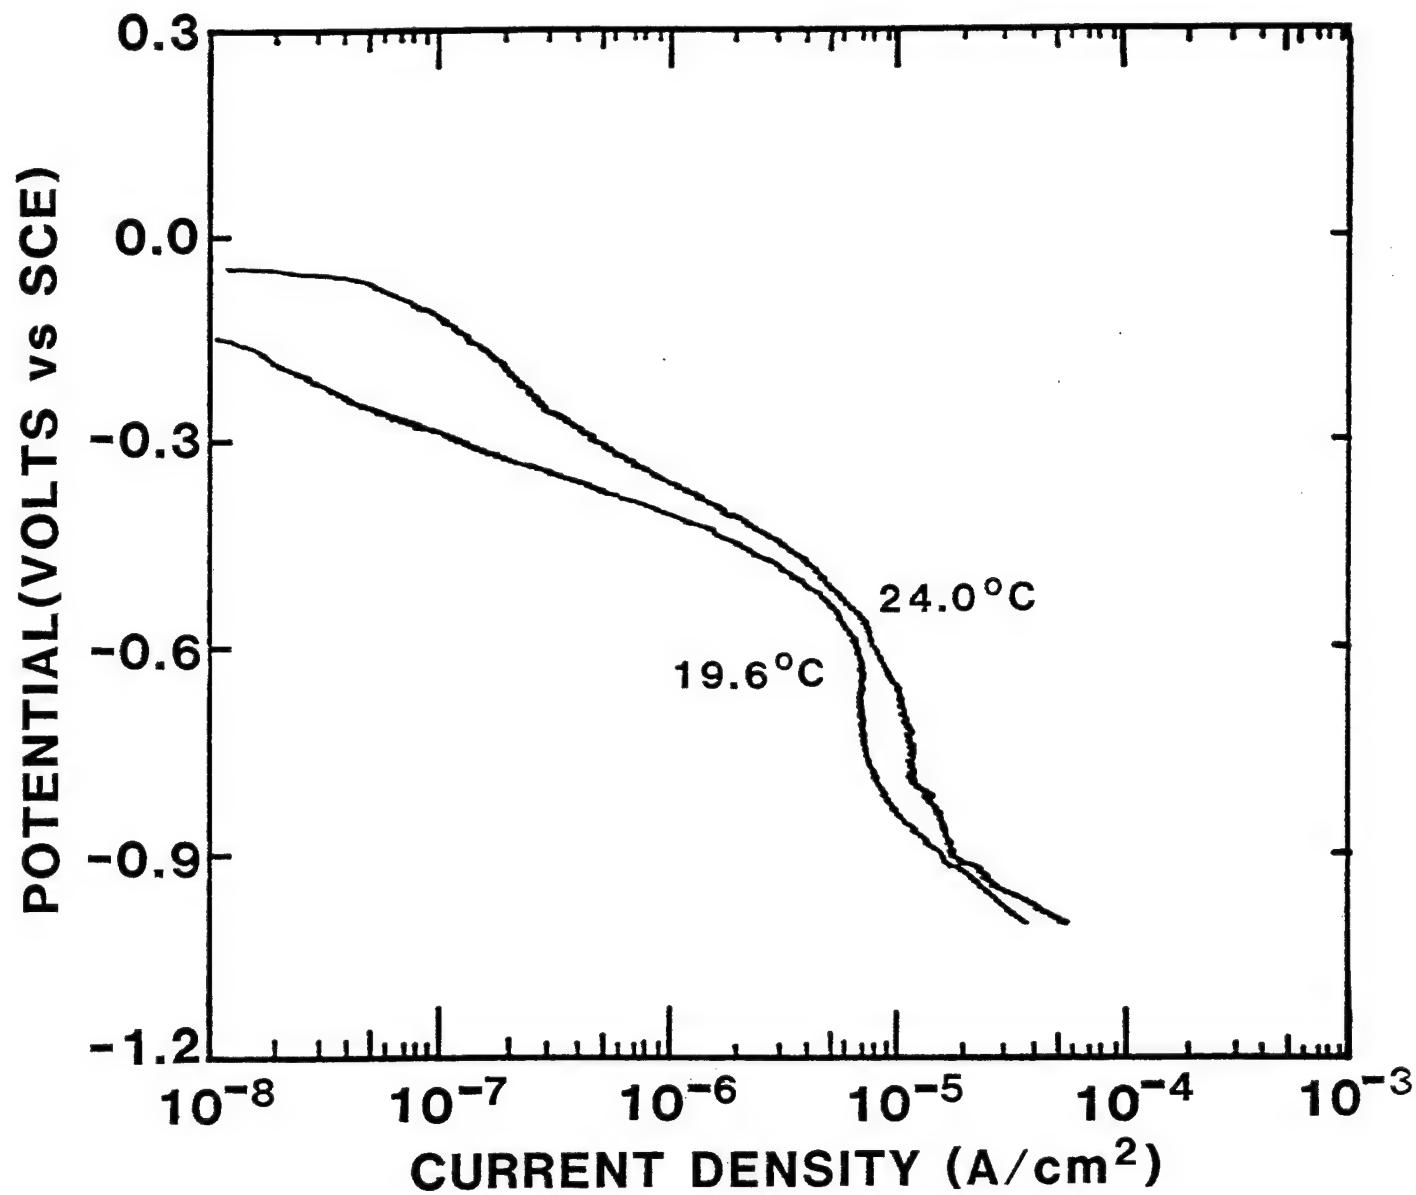
Figure 18. Cathodic polarization behavior for electropolished N06625 pipe pre-exposed to ambient temperature seawater for 12 days.

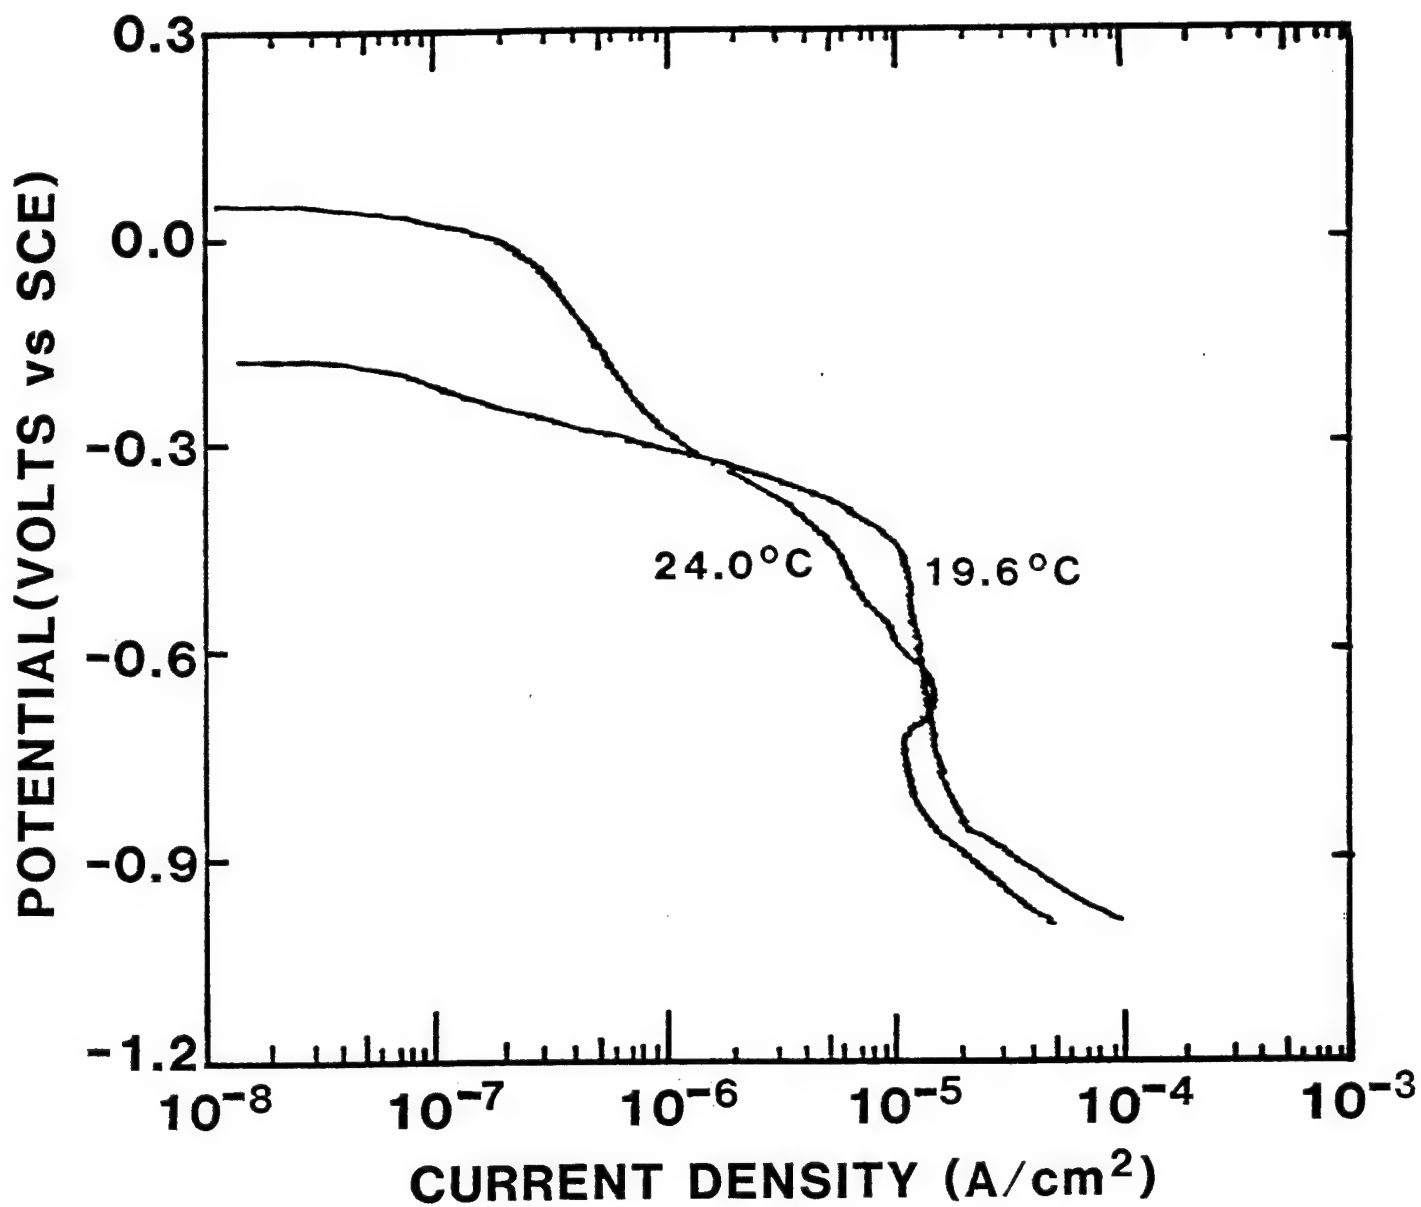
Figure 19. Cathodic polarization behavior of cerium (A) treated N06625 pipe pre-exposed to ambient temperature seawater for 12 days.

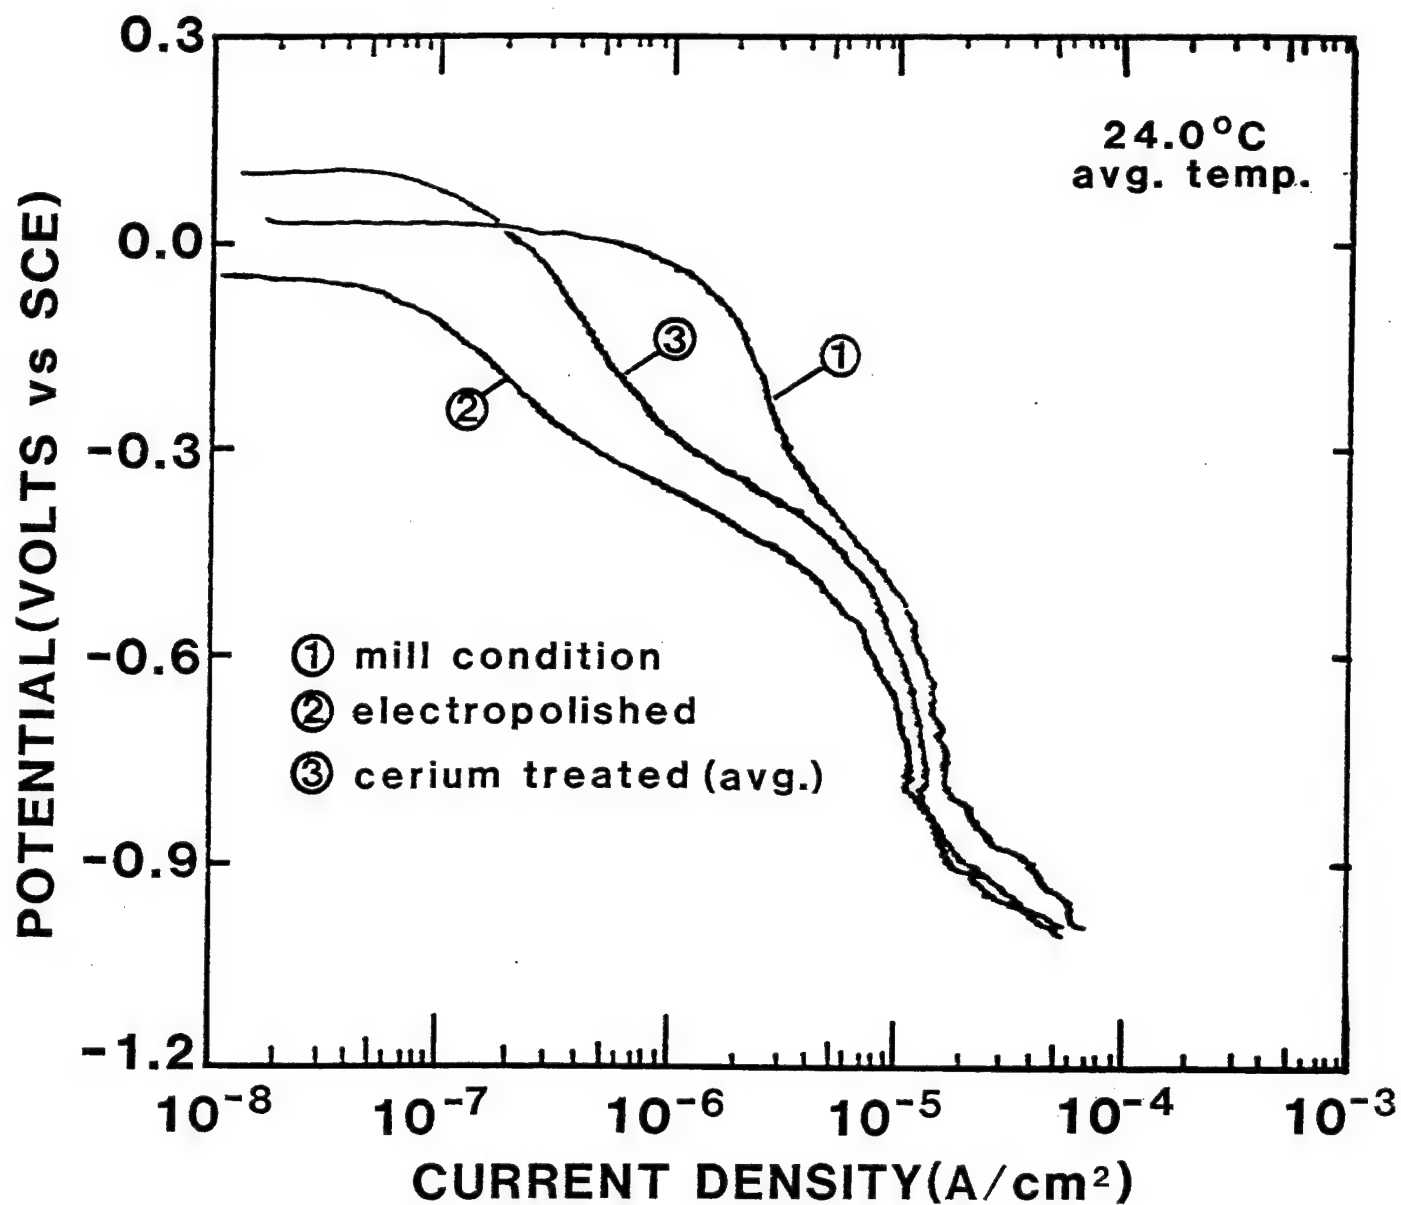
Figure 20. Cathodic polarization curves for as-produced, electropolished and cerium treated N06625 pipe pre-exposed to ambient temperature seawater for 12 days.
